Low-Earth Orbit Flight Test of an Inflatable Decelerator (LOFTID) Aeroshell Performance

Stephen J. Hughes, Dr. Neil Cheatwood, John M. DiNonno
NASA Langley Research Center

AIAA SciTech Forum
8-12 January 2024

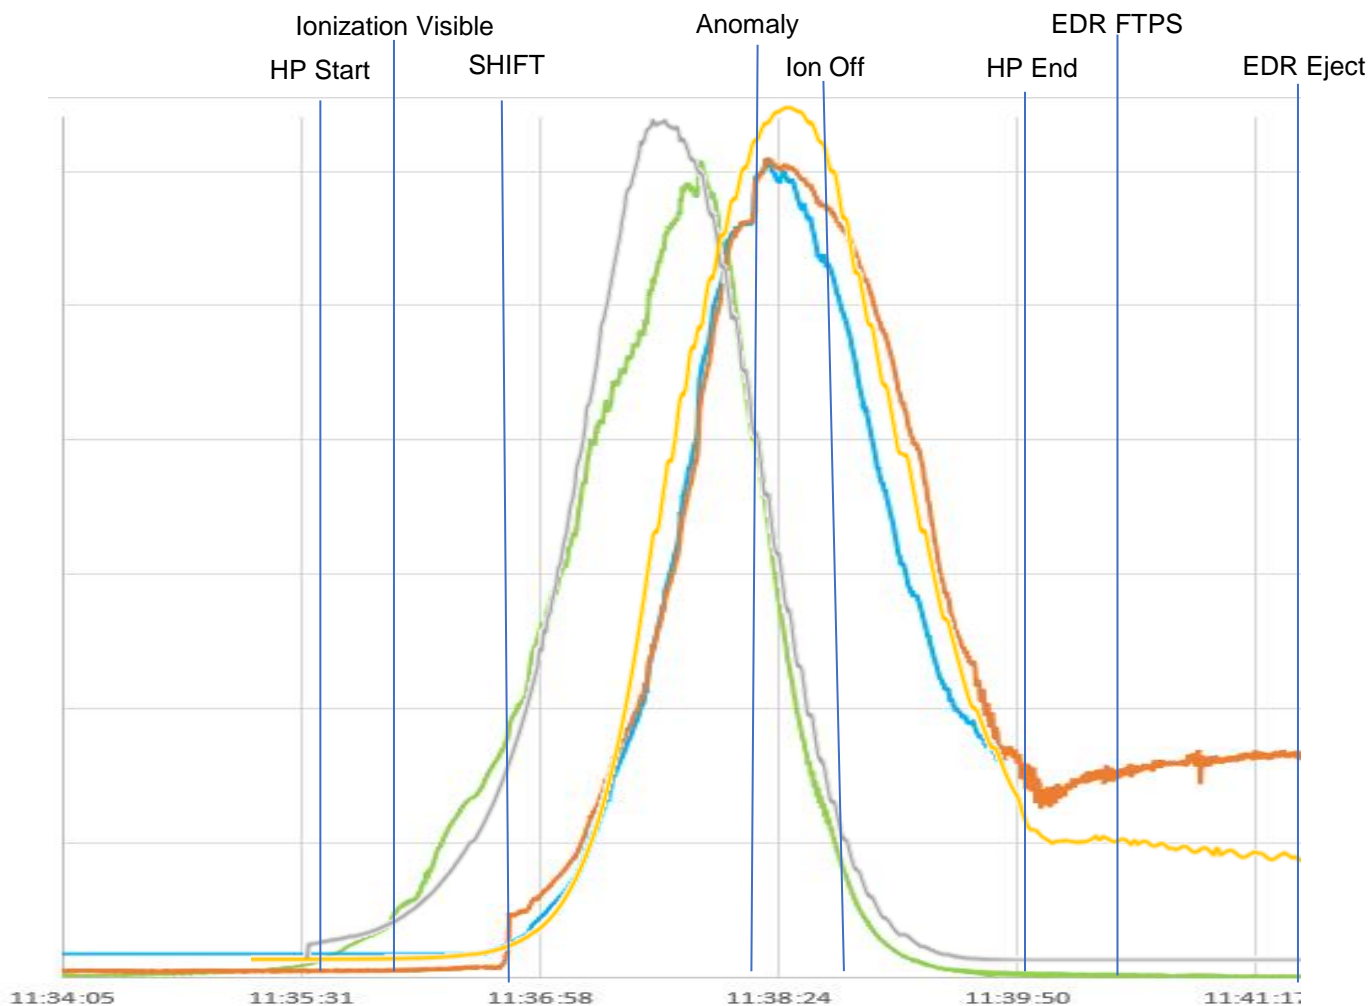
IDR ADAU HFG/LCP/Nose PT vs Pre-Flight Prediction

POST Pressure Pulse (prediction)
POST Heat Pulse (prediction)
Flight Heat Flux Gage (HFG)
Flight Strap Load Cell (LCP)
Surface Pressure Transducer (PT)

Note: The amplitude of the actual flight data was stretched to approximate the same magnitude of the pre-flight middle window prediction showing the shape/timing of events was generally in line with the POST simulation

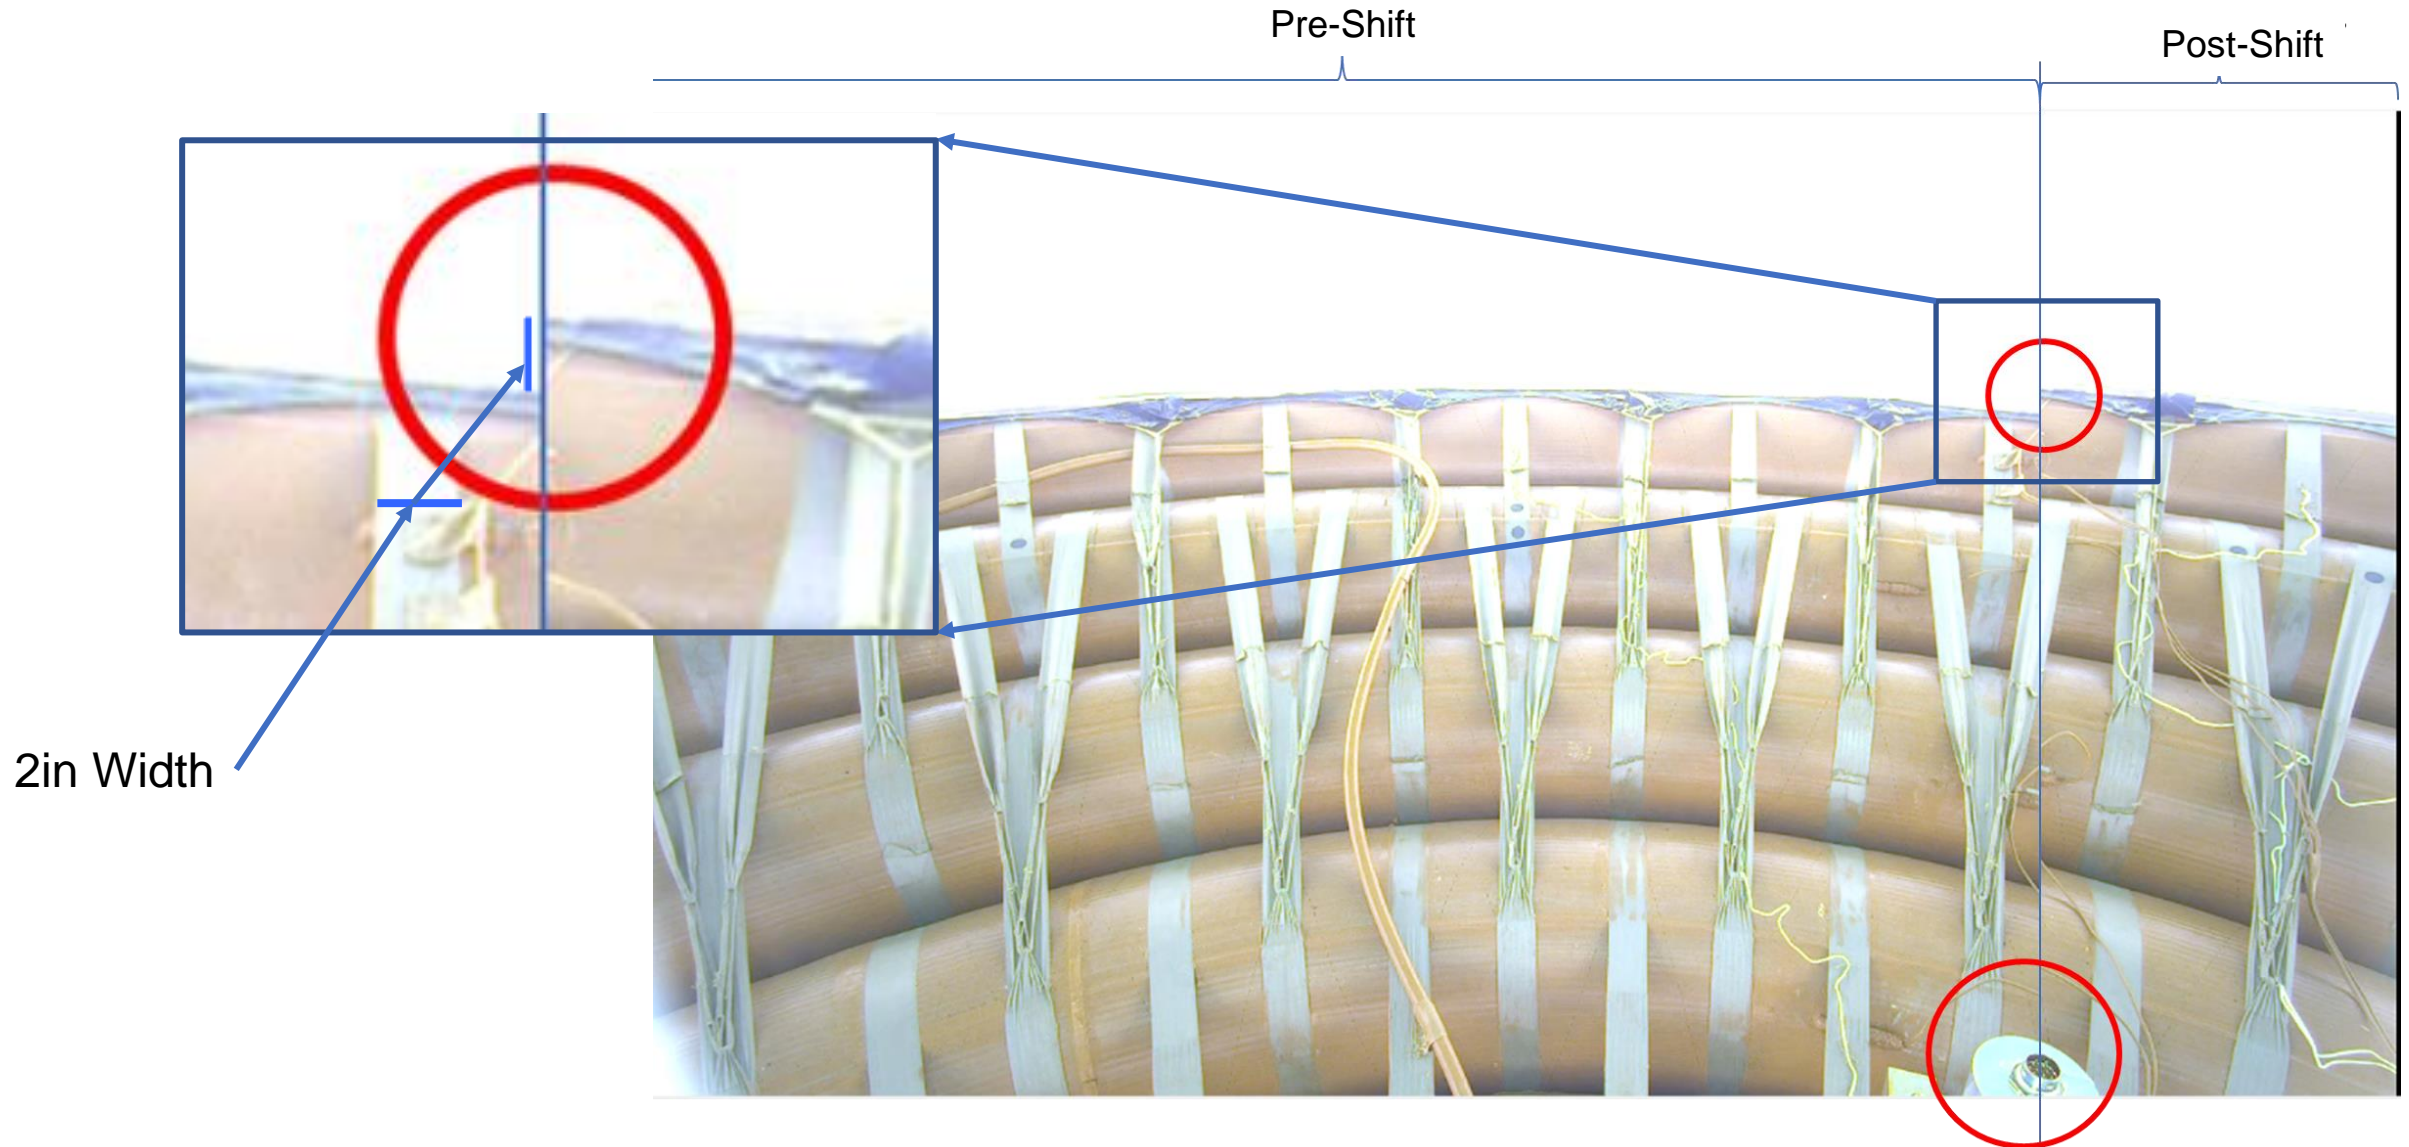
CP1 Aeroshell Aft Shift

~4in deflection

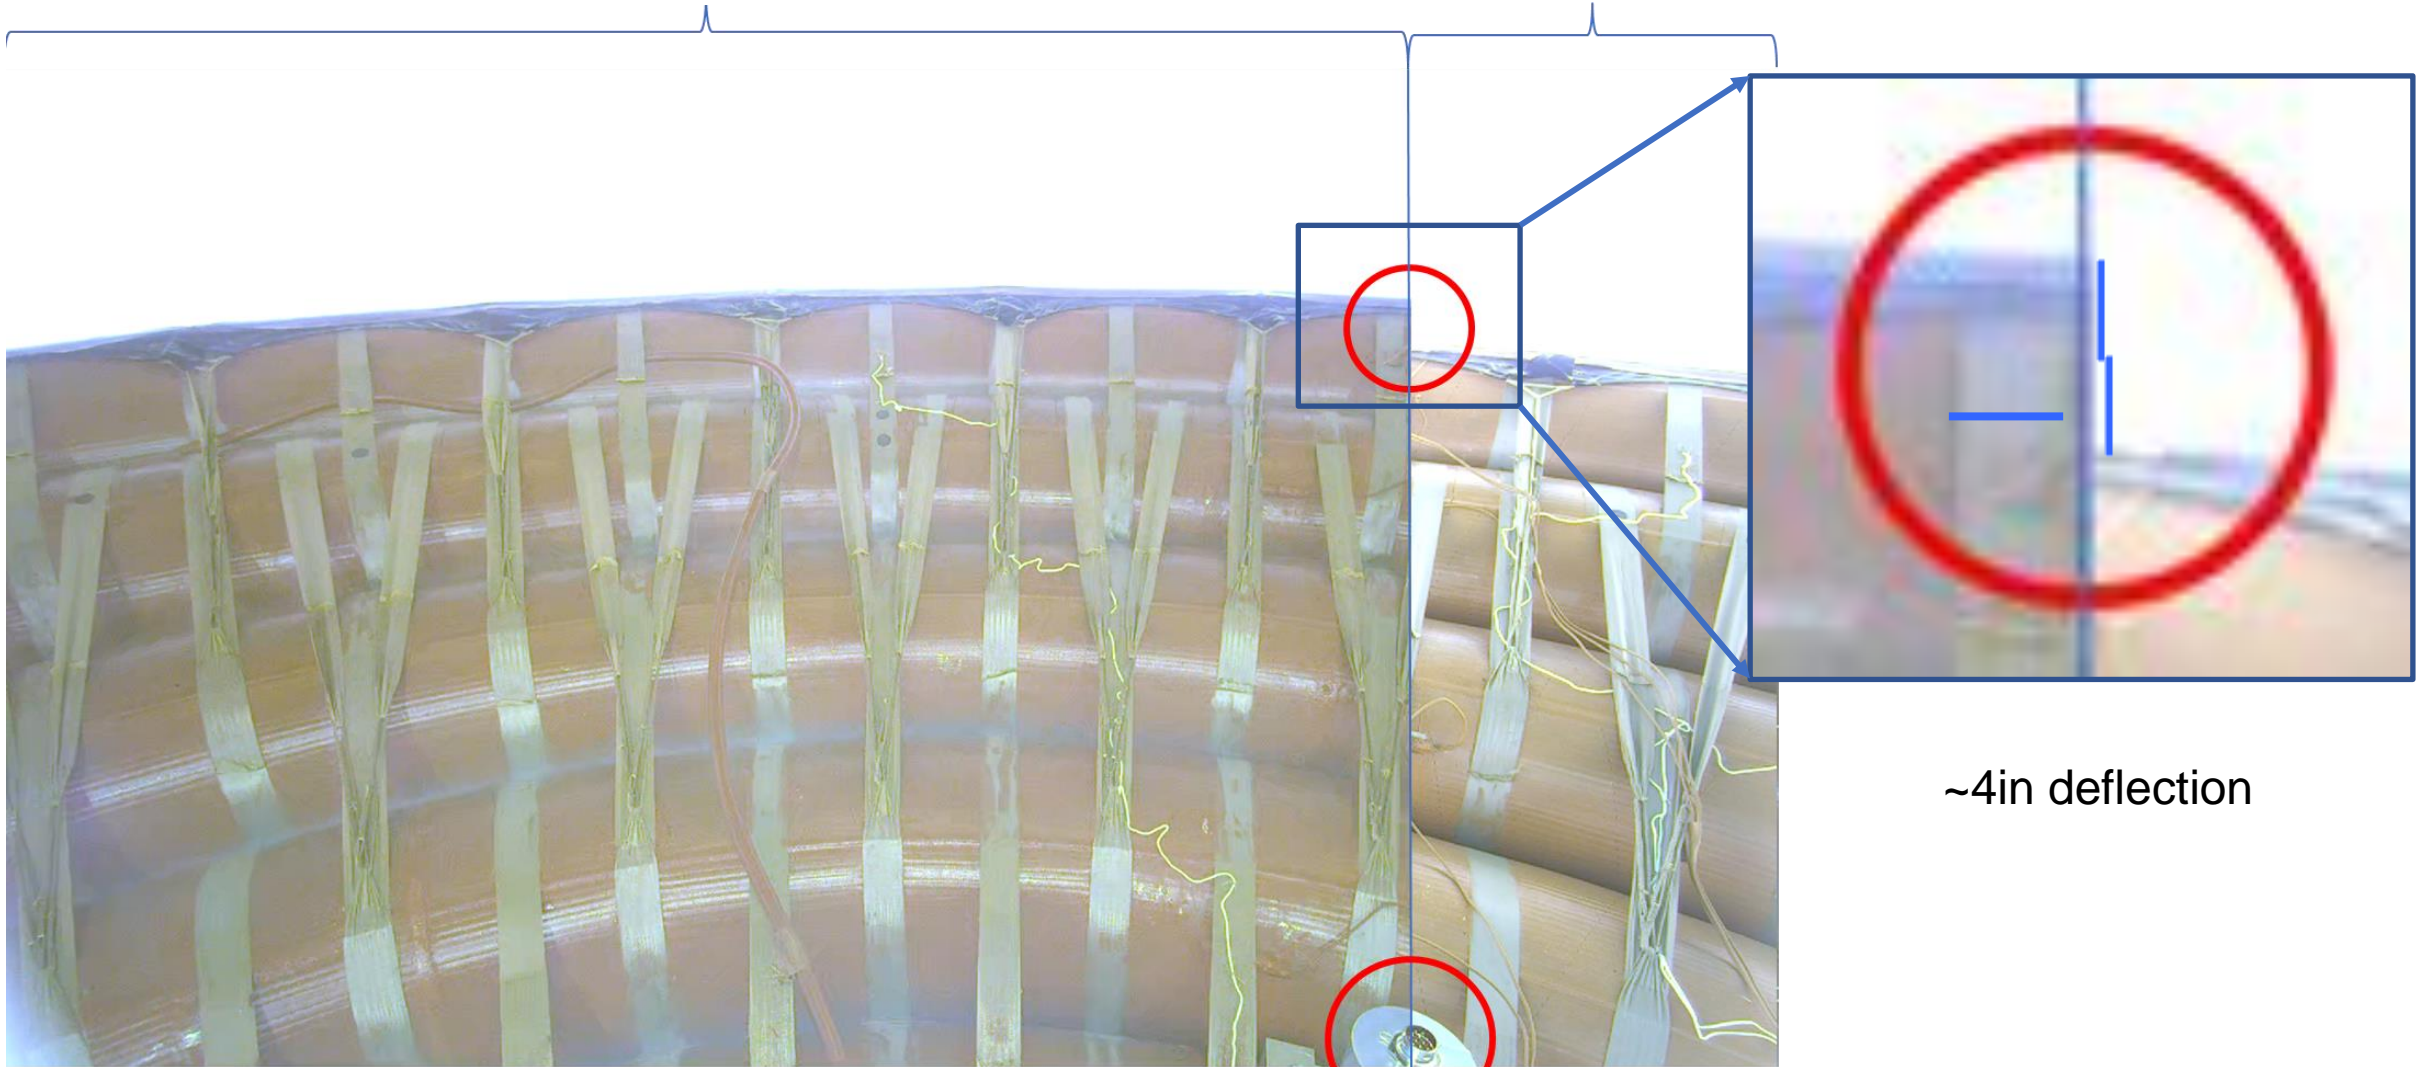
CP1 Peak Dynamic Pressure vs Beginning Pressure Pulse

Peak Dynamic Pressure

Beginning Pressure Pulse

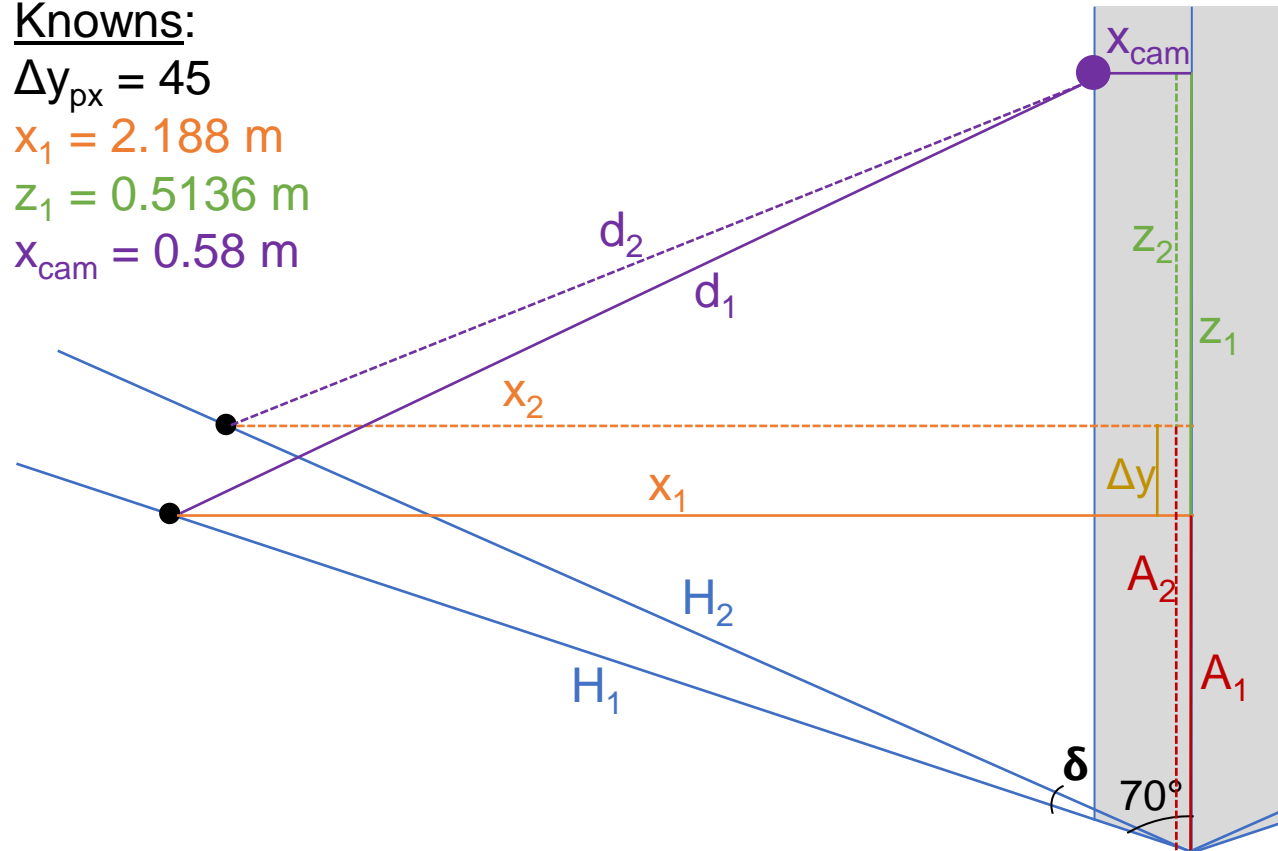
Deflection Angle Calculation Example

Measured distances between camera and dot (from CAD):

X: 62.7393 in = 1.5936 m

Y: 8.4395 in = 0.2144 m

Z: 20.2198 in = 0.5136 m

$$\text{Resolution (y-direction)} = \frac{56.7^\circ}{1080 \text{ px}} = 0.0525^\circ/\text{px}$$

$$d_1 = \sqrt{(x_1 - x_{cam})^2 + z_1^2} = 1.688 \text{ m}$$

$$s_1 = 1.688 \tan(0.0525^\circ) \approx s_2 = 0.0015 \text{ m/px}$$

$$\Delta y = 25 \text{ px} \times 0.0015 \frac{\text{m}}{\text{px}} = 0.03867 \text{ m}$$

$$z_2 = 0.5136 - 0.03867 = 0.4749 \text{ m}$$

$$A_1 = \frac{2.188}{\tan 70^\circ} = 0.7964 \text{ m}$$

$$H_1 = \frac{2.188}{\sin 70^\circ} = 2.3283 \text{ m}$$

$$A_2 = 0.7963 + 0.5136 - 0.4749 = 0.8351 \text{ m}$$

$$\delta = 70^\circ - \cos^{-1}\left(\frac{0.8351}{2.3283}\right) = 1.02^\circ$$

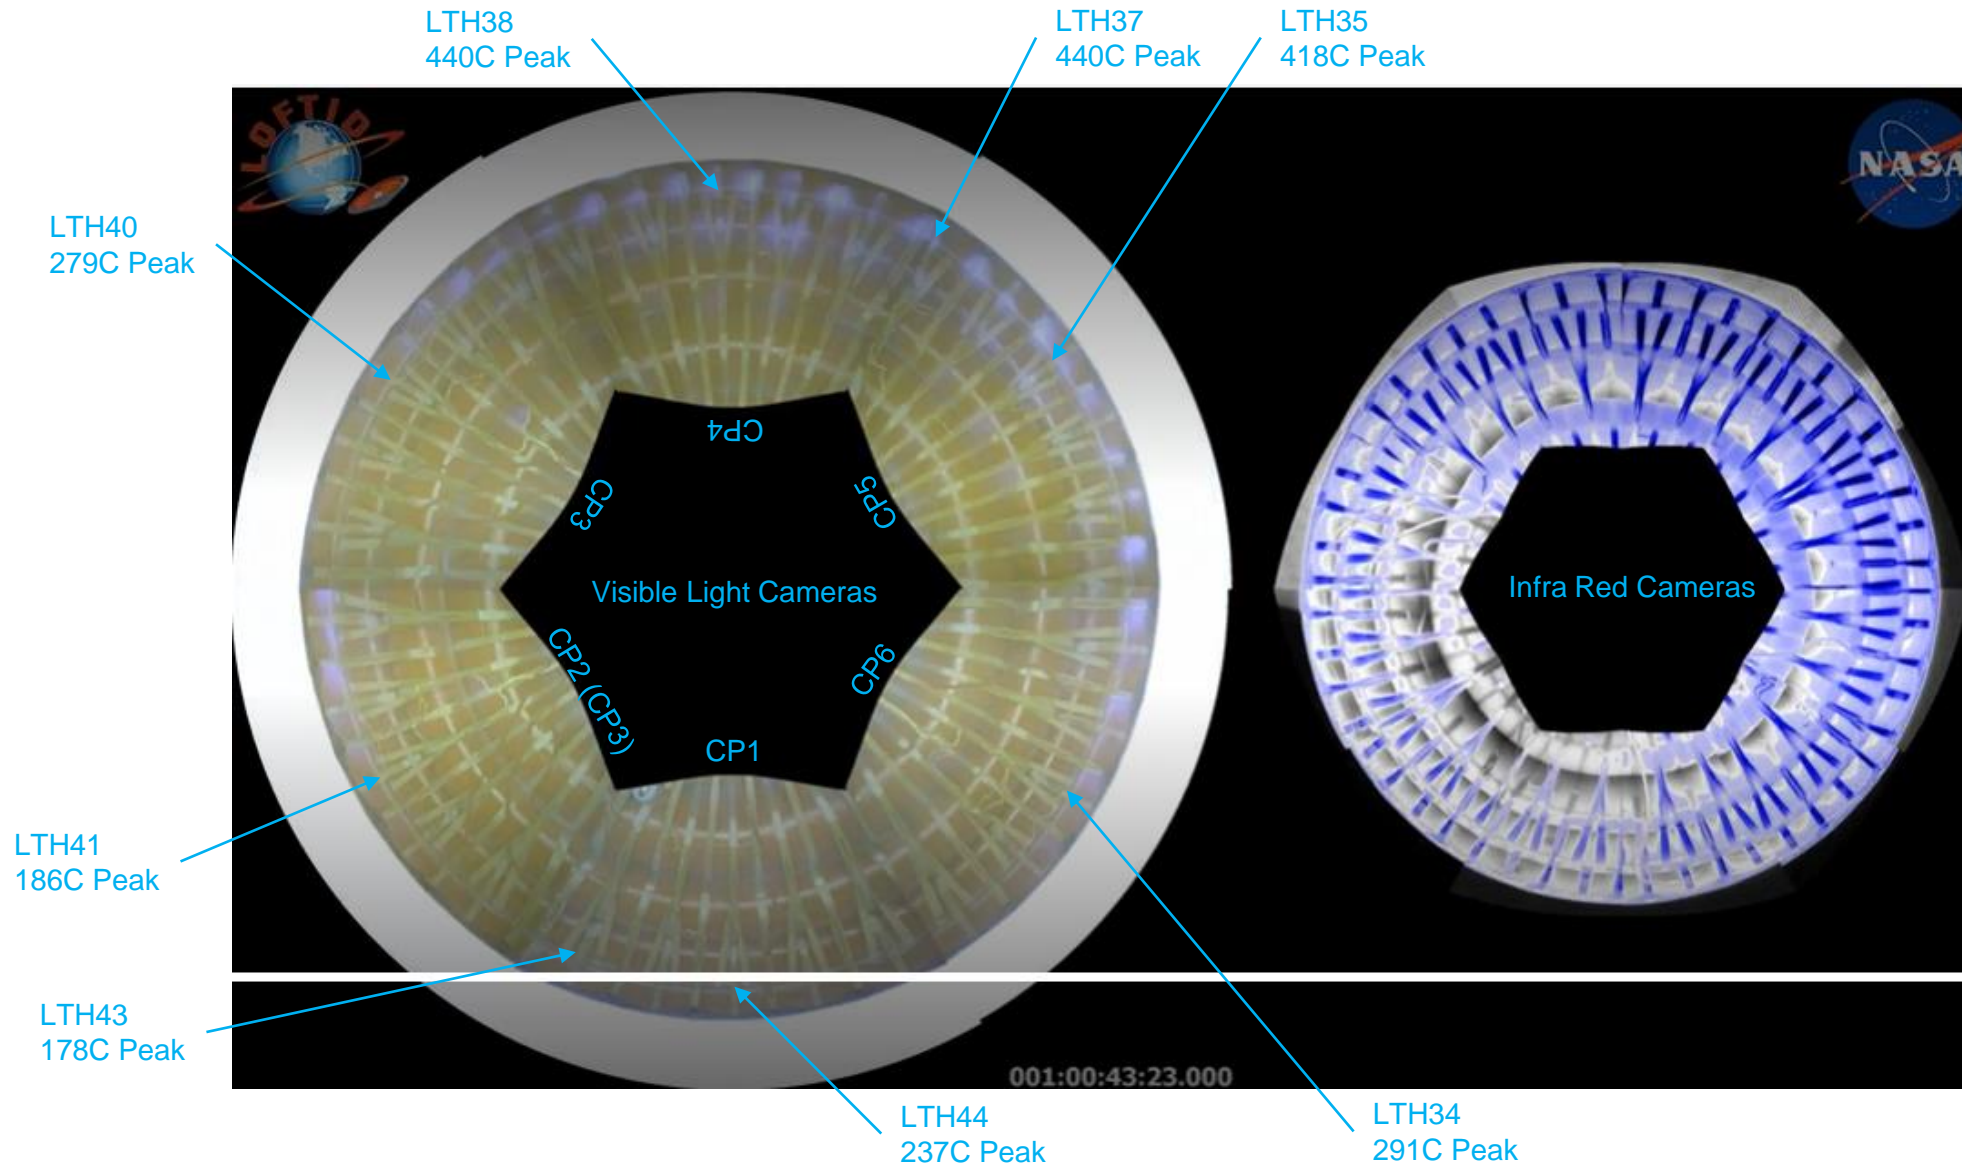
Aft Webbing Temperature and Plasma Locations

Note: CP2 Visible Light Camera failed and is a duplicate of CP3 in the composite

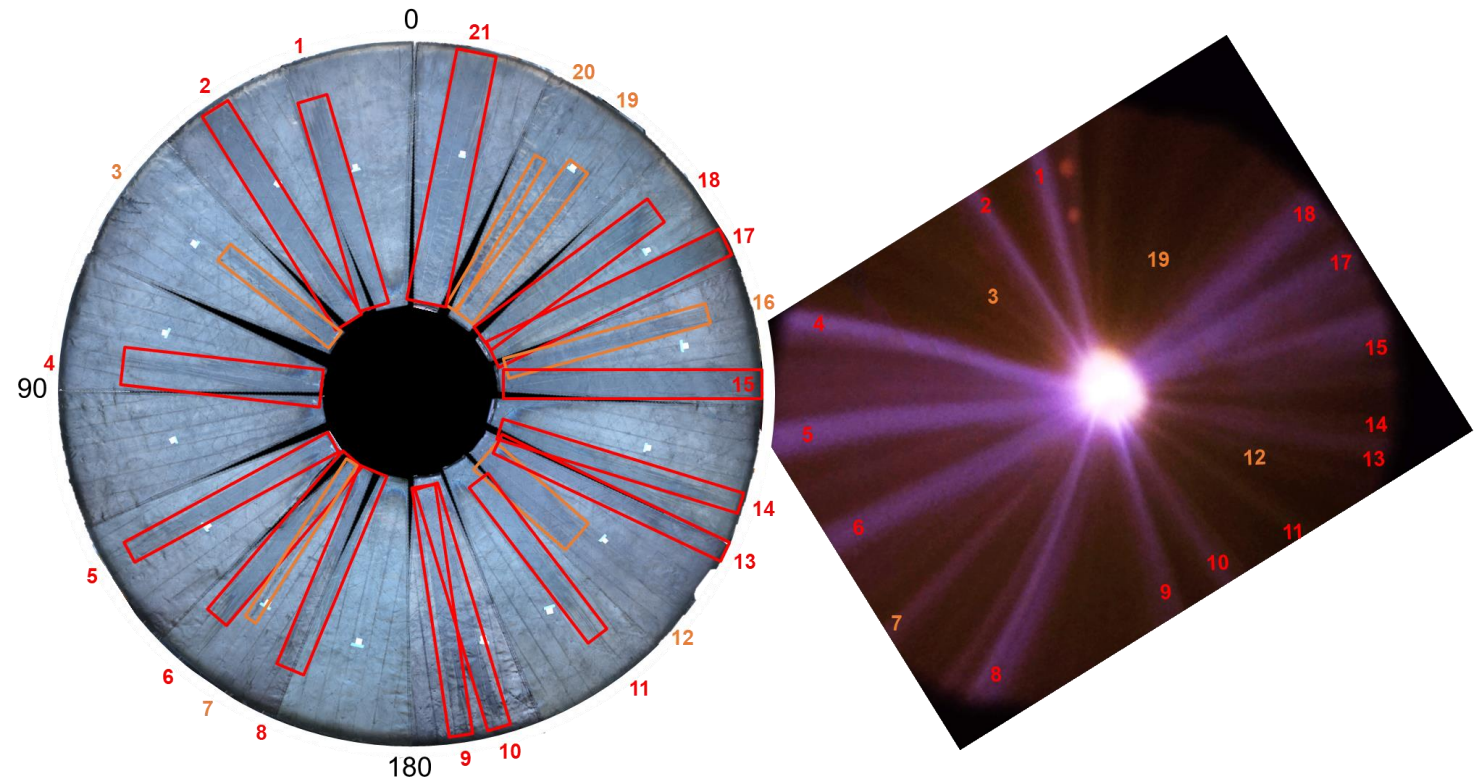
Later in the pulse well past peak pressure many more rays are present, not equally spaced, possibly lined up with the streaks on the forward Aeroshell surface

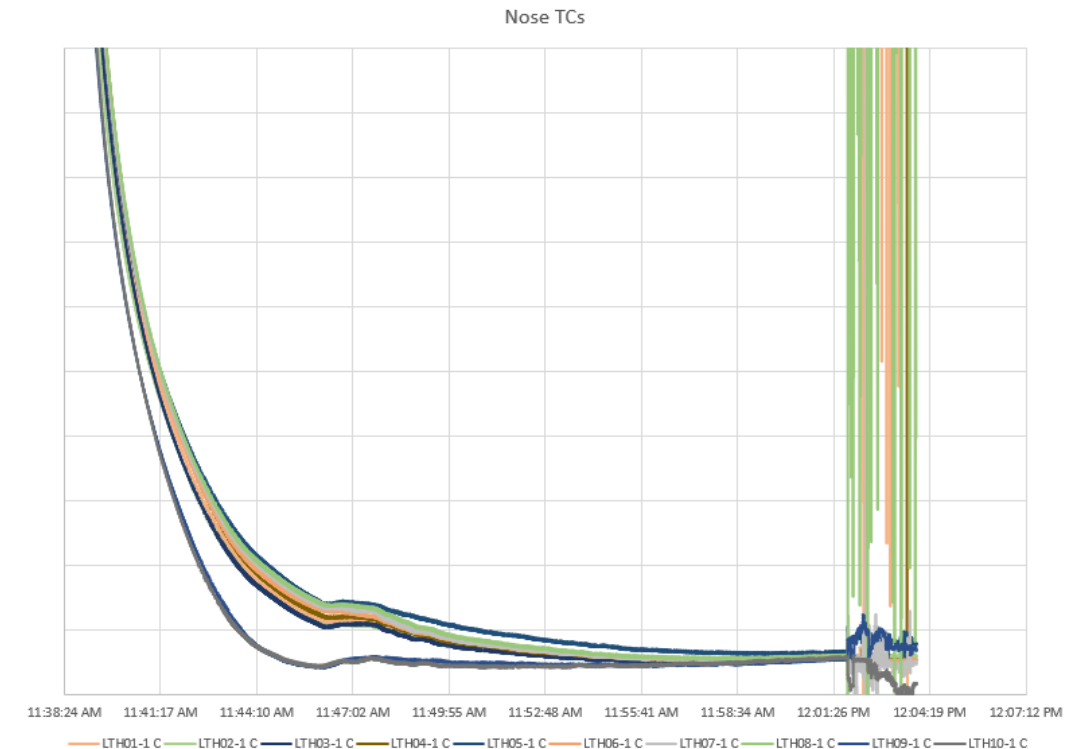
Note: The nose FTPS was lost some time between water impact and lifting out of the water. The plot in the lower right is the plot of nose TCs during descent. The bump up aligns with the deployment of the pilot and main chute. The insulators which are warmer at this point recontact the outer fabric and bump up the temperature. TC plots look fine after the bump until water impact.
